AFWAL-TR-85-2006

**COMPATIBILITY OF SODIUM AND
LITHIUM IN SUPERALLOY HEAT PIPES**

April 1985

Final Report for Period 1 January - 31 December 84

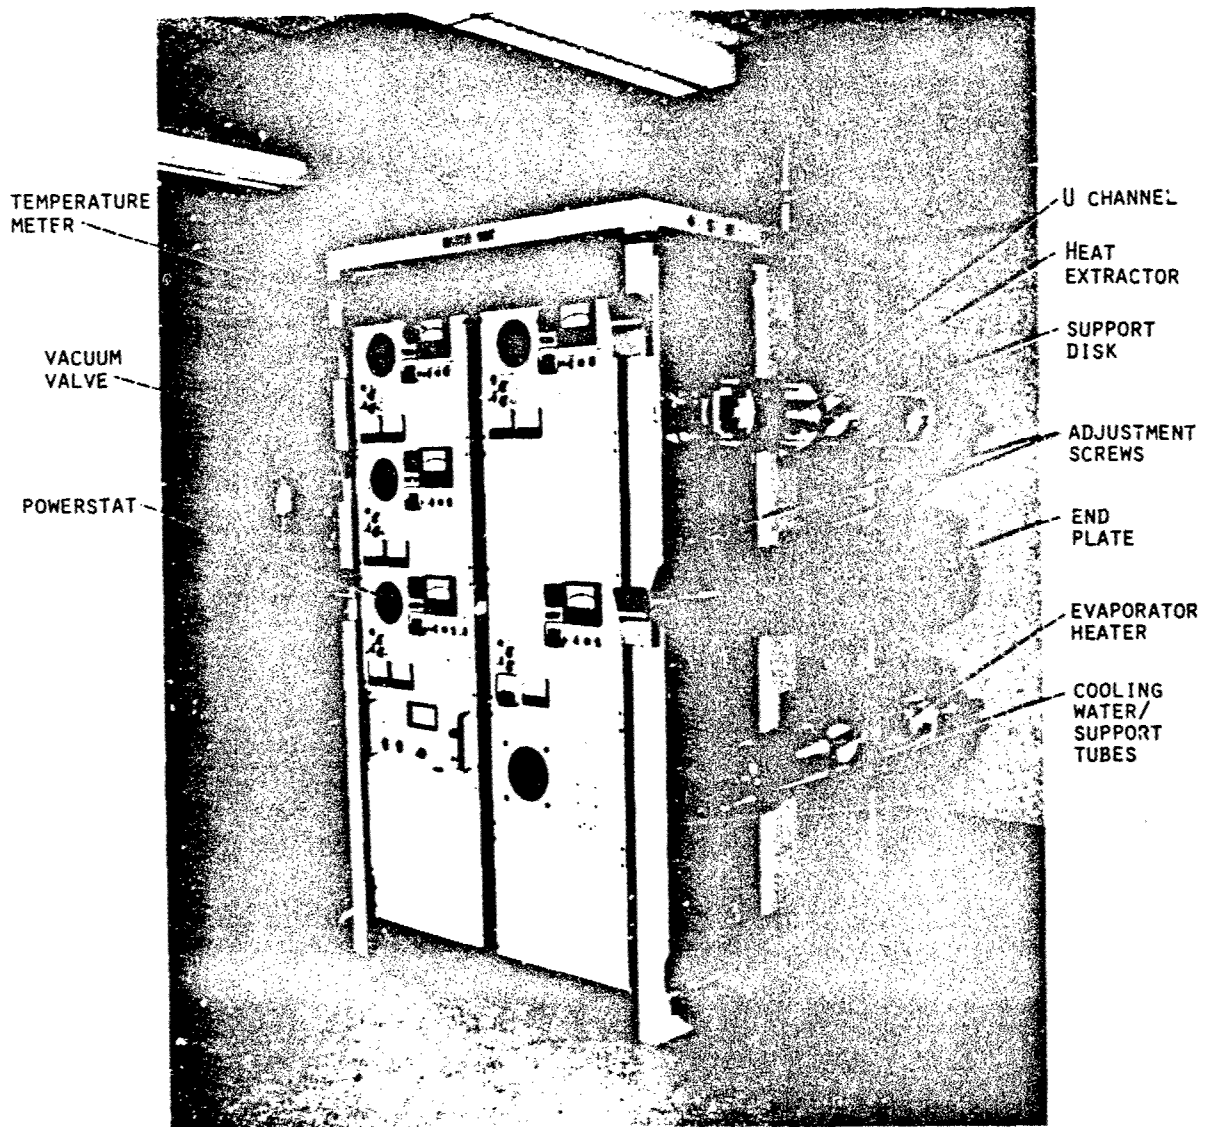
Three air environment test stations can be seen on the right side of the stand in Fig. 2. The top and bottom stations have the chambers removed and one chamber lies on the

FIGURE 2. - LEFT TEST STAND SHOWING STATION DETAIL.

floor. The chamber end plate and internal structure of each station were supported by two bolts that passed through the heavy gauge U-shaped channel at its far end and were threaded into the edge of the end plate, top and bottom. In a vacuum environment station, the chamber was bolted to the end plate using a copper gasket as a seal. For an air environment station, the chamber was bolted loosely to leave about a half centimeter gap. No seal was required. The assembly was also supported at the midpoint of the chamber by adjustment screws that threaded through the near end of the U-shaped channel at the top and bottom.

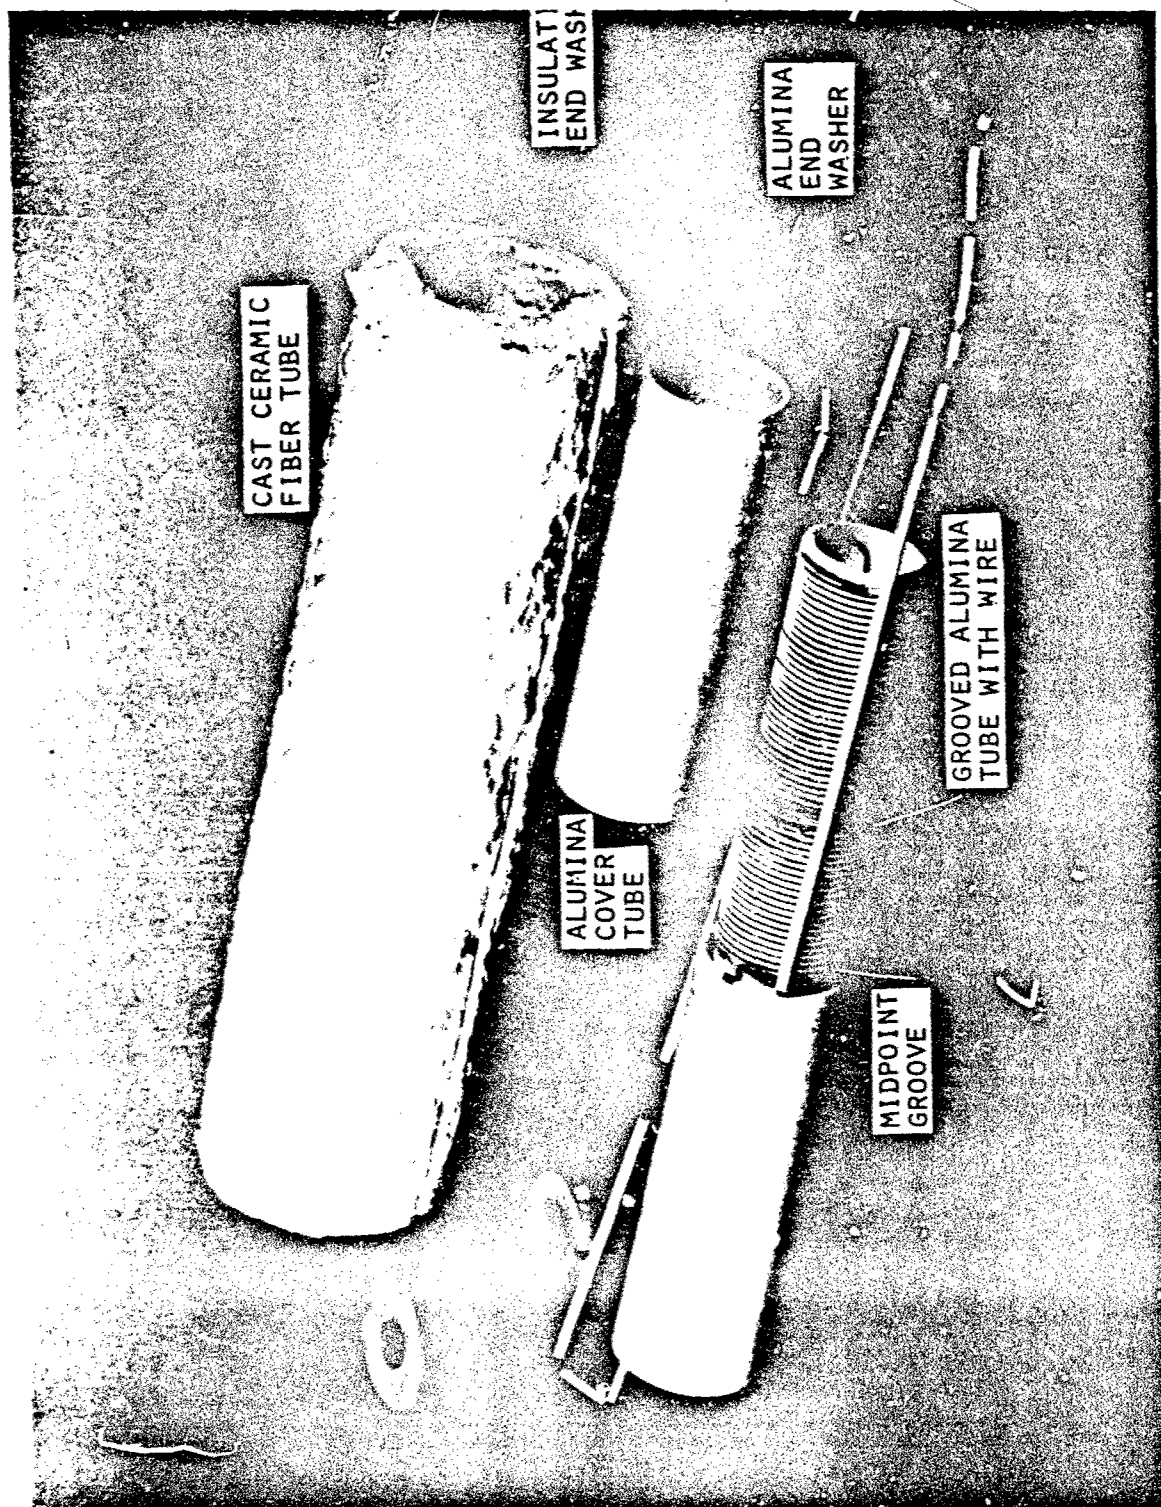
Components of the original heater for use in the air environment tests are illustrated in Fig. 3(a). The heating element wire was wound on a 4.8 cm diameter by 35.5 cm long tube of 98 percent alumina. The tube was cast with a 0.32 cm wide by 0.16 cm deep helical groove from each end to the midpoint. At midpoint was a 0.64 cm square circumferential groove. Kanthal A resistance wire was used to wind coils in the helical grooves from the ends of the alumina tube toward the midpoint groove. The ends of the two coils meeting in the midpoint groove were twisted together and lead to the forward end of the heater in a small alumina tube. The leads from the outer ends of the coils were twisted together to form the other lead. Therefore, the coils operated in parallel. A separate piece of wire was wrapped in the midpoint groove and in each end

(A) HEATER AS ORIGINALLY DESIGNED.

FIGURE 3. - EVAPORATOR HEATER FOR AIR ENVIRONMENT STATIONS.

These heaters were designed to produce about 1200 W and operate to 1200 °C. However, when tested in a prototype facility with a superalloy 304L stainless steel heat pipe, not only did the heater collapse into a melted lump of material, but extensive external reaction destroyed the heat pipe. Unfortunately, chemical or metallurgical analysis of the failure was not made, but observation suggested that the small percentage of silica present in the grooved tube was primarily responsible.

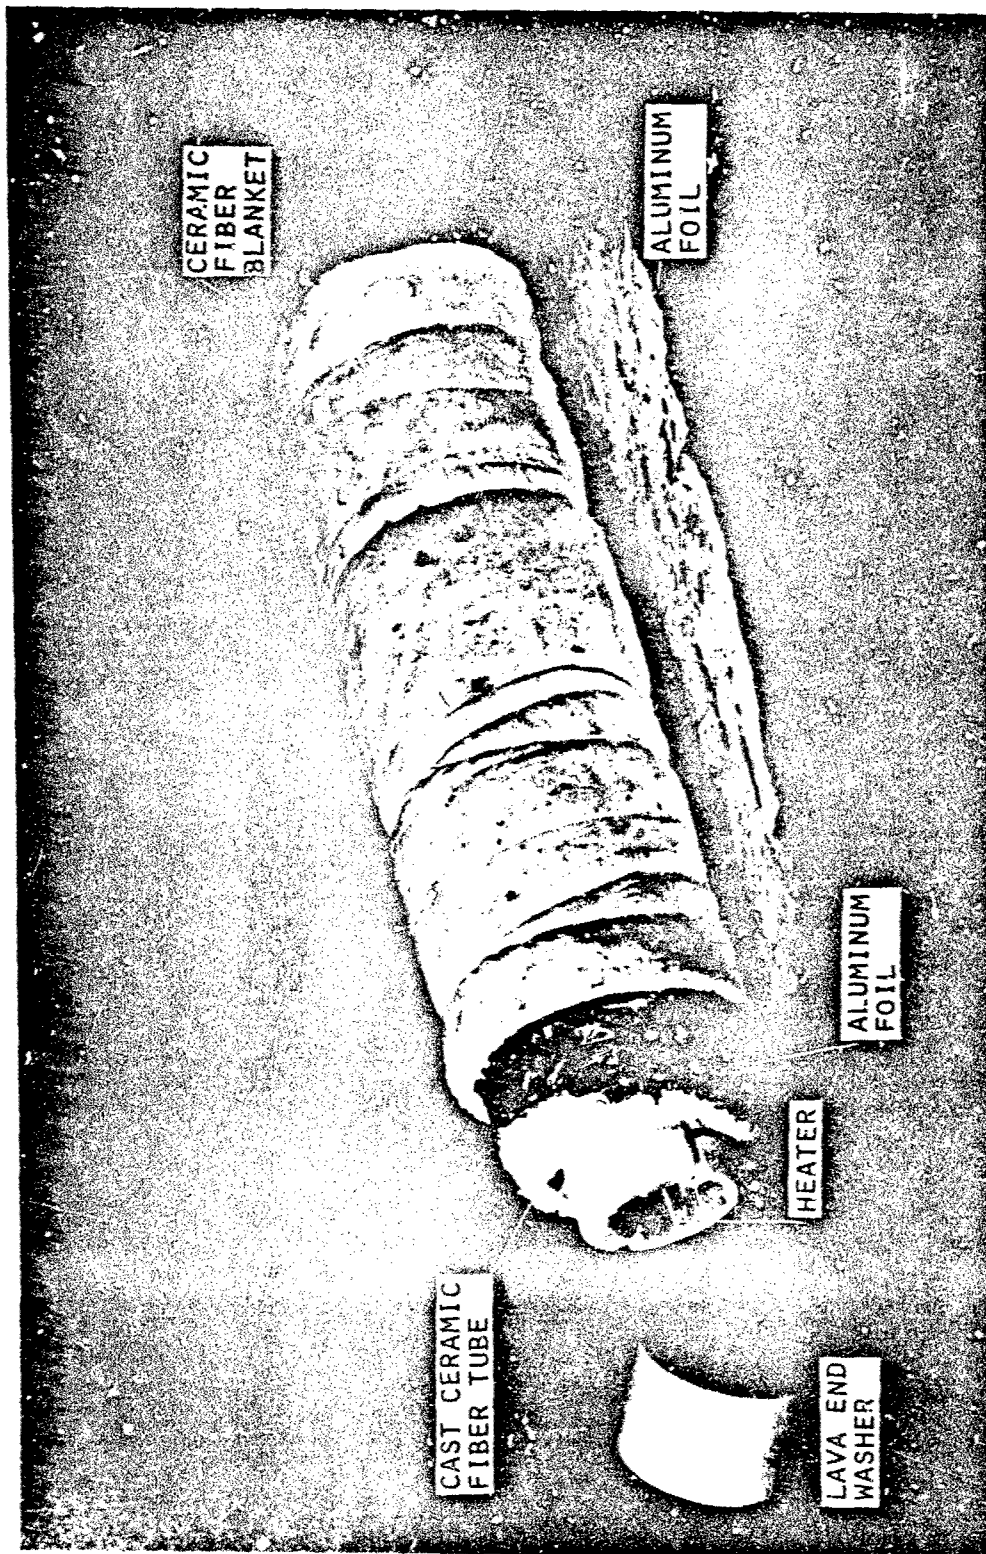
A second evaporator heater was constructed using a commercially available electric heating element housed in silica-free alumina (Electro-Applications, Inc. Model SK-118). The 4.1 cm I.D. cylindrical tube was comprised of two halves as shown in Fig. 3(b). The wire ends of each half were twisted together so that the two halves operated in parallel to provide 1200 W. The unit, capable of temperatures to 1200 °C was inserted into the 10 cm O.D. insulating tube of cast alumina-silica fiber. Two layers of heavy gauge aluminum foil were wrapped over the outside of the tube followed by one layer of alumina-silica ceramic fiber blanket about 1.27 cm thick. Admittedly, the cast tube and the blanket contained silica but they operated at a much lower temperature than the heater core of the original heater. The whole assembly was then wrapped with another layer of aluminum foil. End losses were minimized by washers about 5 cm thick machined from lava.

(B) HEATER, FINAL DESIGN.

FIGURE 3. - EVAPORATOR HEATERS FOR AIR ENVIRONMENT STATIONS.

Both heaters were supported and centered about the heat pipe by 1.3 cm long stainless steel cylindrical sections fastened to the first and second support disks. While a few failures were experienced over the course of the tests, the heaters as a whole operated satisfactorily as long as 15,000 to 23,000 hr of continuous testing.

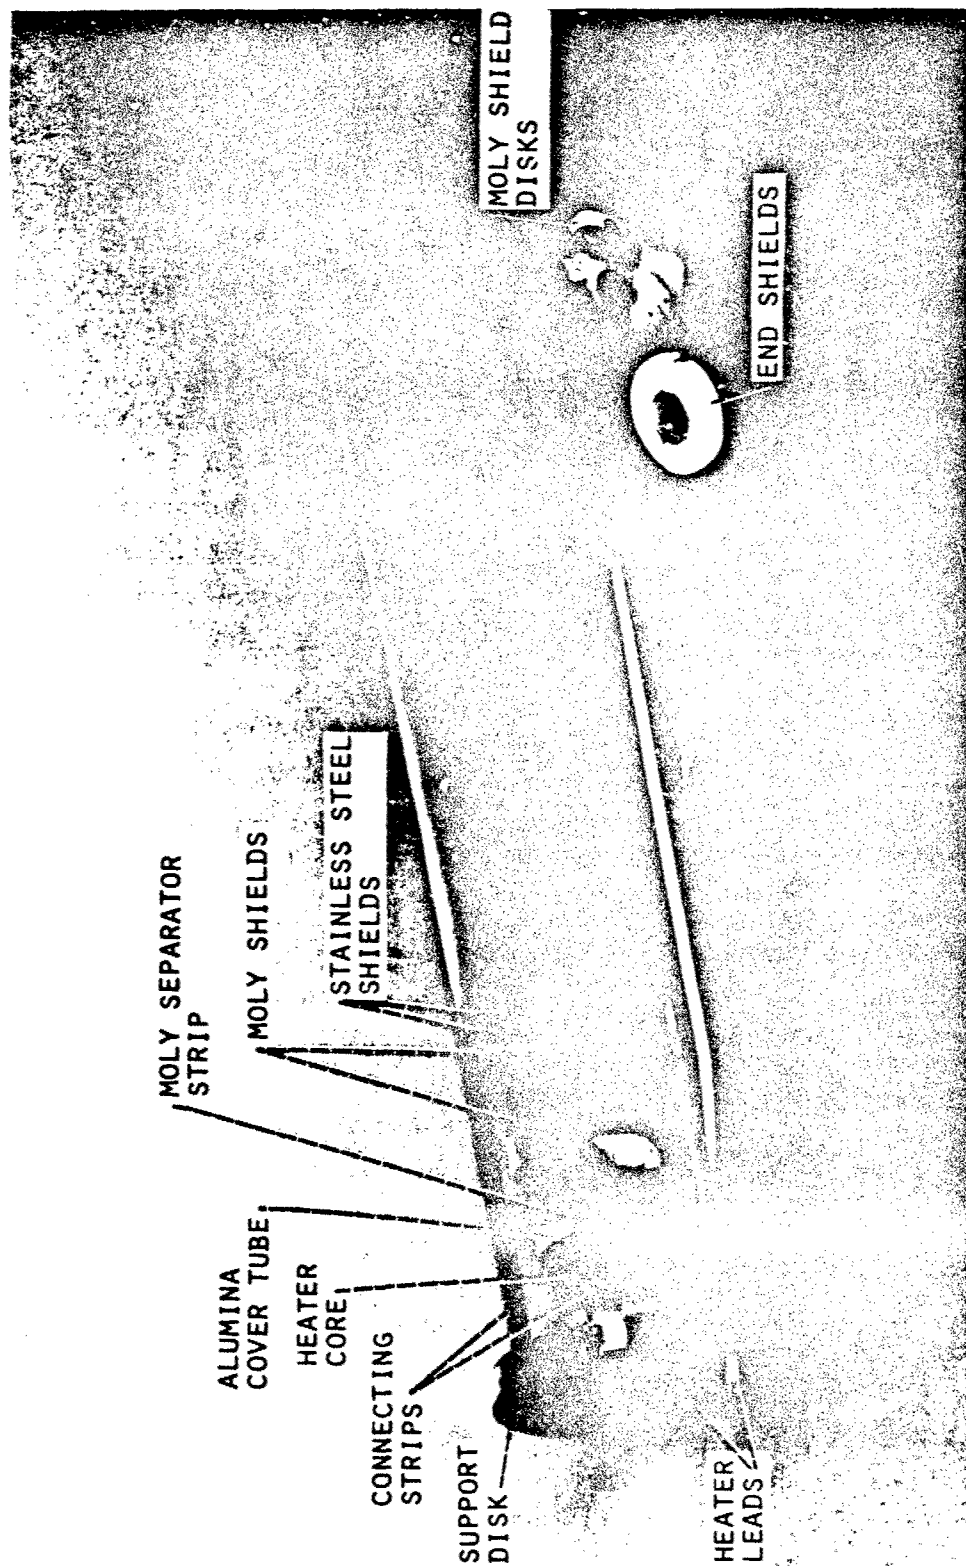
The heater core was inserted into a 7.9 cm diameter high purity alumina cover tube that extended about 1.27 cm beyond the core ends. The assembly was then inserted into a radiation shield consisting of four concentric cylinders. The inner two were fabricated of 0.0127 cm thick moly sheet. Corrugated strips of 0.0127 cm thick moly separated the innermost cylinder from the alumina tube and the second cylindrical shield from the first. Because of poor ductility of moly, the two inner shields could not be

(A) ASSEMBLED.

FIGURE 4. - EVAPORATOR HEATER FOR VACUUM ENVIRONMENT STATIONS.

(B) INTERNAL PARTS.

The innermost heat shields to prevent end losses were disks of 0.63 cm thick boron-nitride. Outside these were four moly disks, each 0.012 cm thick. The disks were spaced apart by small moly tabs spot welded to the disks. The heater element leads were electrically insulated from the metal end shields as they exited the assembly by short sections of high purity alumina tube. The aft lead was brought to the front end of the heater in a length of the same kind of tubing. The end flanges were tied together by three vee-shaped connecting strips of stainless steel sheet. The heater assembly was supported on each end by short cylindrical sections welded to the first and second support disks.

The heaters were capable of operating at 1200 W which proved to be greater than required for this group of pipes. There were no failures among the five heaters used. Four operated in excess of 25,800 hr each.

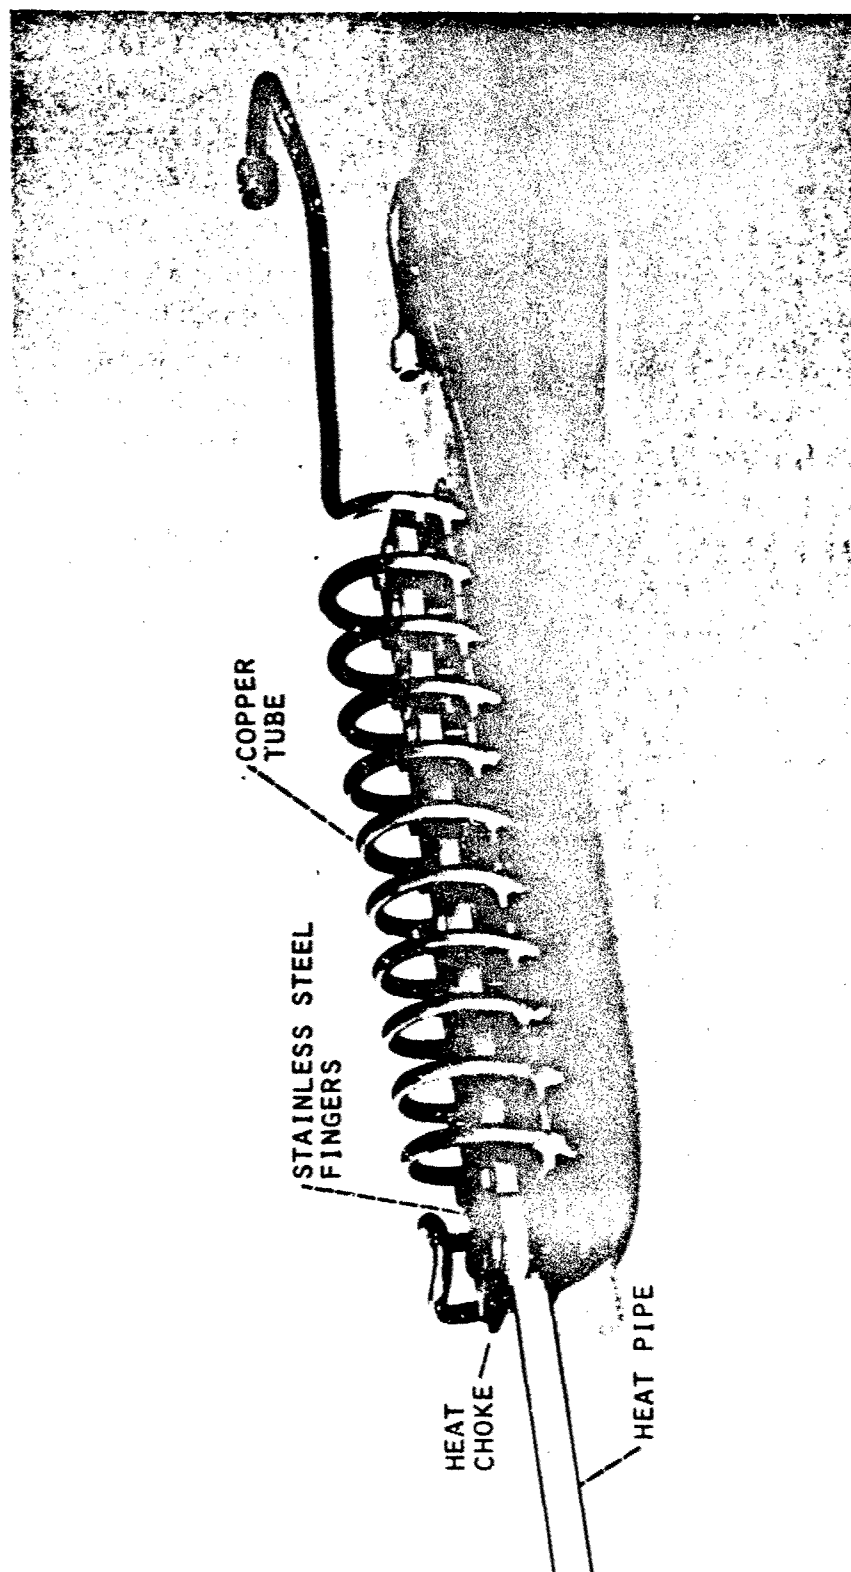
The heat extractor, as originally designed, is pictured in Fig. 5(a). It was to be capable of removing about 600 W from the condenser section of a 1.27 cm diameter heat pipe by conduction from the pipe wall to the cooling water. It consisted of twelve pairs of stainless steel fingers and a helical coil of 0.63 cm diameter copper tubing. Each finger was $\sqrt{2.5}$ cm wide and 2.86 cm long. The fingers were 0.79 cm thick along most of their length for strength purposes. In order to provide a thermal resistance between the condenser and the heat sink, the thickness was decreased to about 0.24 cm near the ends that were brazed to the copper coil. A 0.63 cm radius was machined into the inside surfaces to accommodate the heat pipe diameter. Two bolts inserted through one side of each pair and threaded into the other were used to draw

(A) CONDUCTION MODEL.

FIGURE 5. - HEAT EXTRACTOR DESIGNS.

The fingers could be sprung out of contact with the heat pipe by loosening the two bolts in alternate pairs, every third pair, or whatever combination was necessary to obtain the desired heat flow rate from the condenser. With this latitude for controlling the heat flux, it was hoped the condenser and, therefore, the heat pipe could be set and maintained at the desired operating temperature. The design was tested in the prototype facility where it became evident that the heat transport capability of the superalloy pipes would require only a fraction of the heat extractor. Thus a simpler heat extractor would be sufficient.

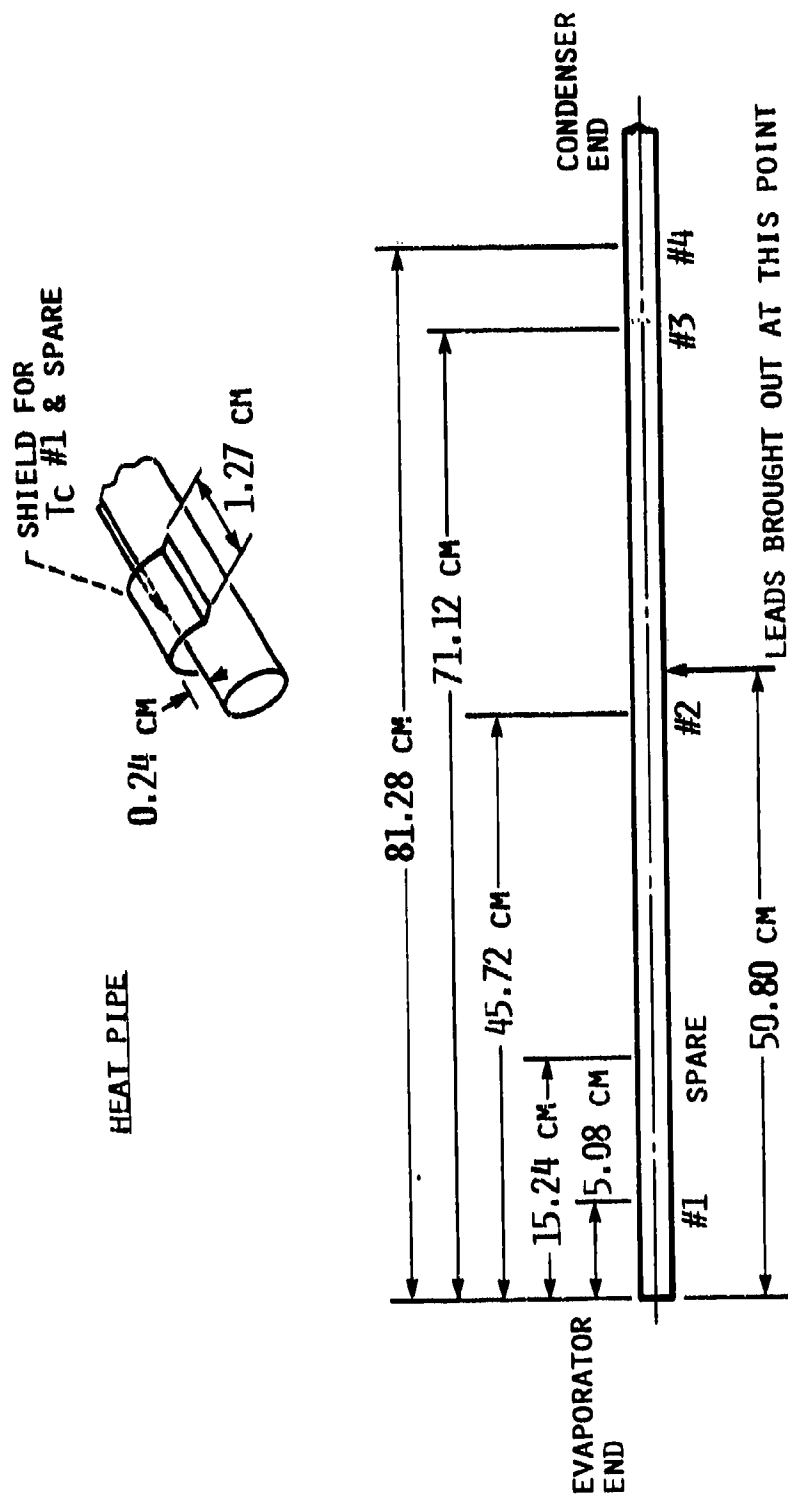
FIGURE 7. - THERMOCOUPLE LOCATIONS.

The spare thermocouple was connected to the selector switch in the event that thermocouple no. 1 failed. Thermocouple failures were generally due to wire breakage adjacent to the spot-welded junction bead.

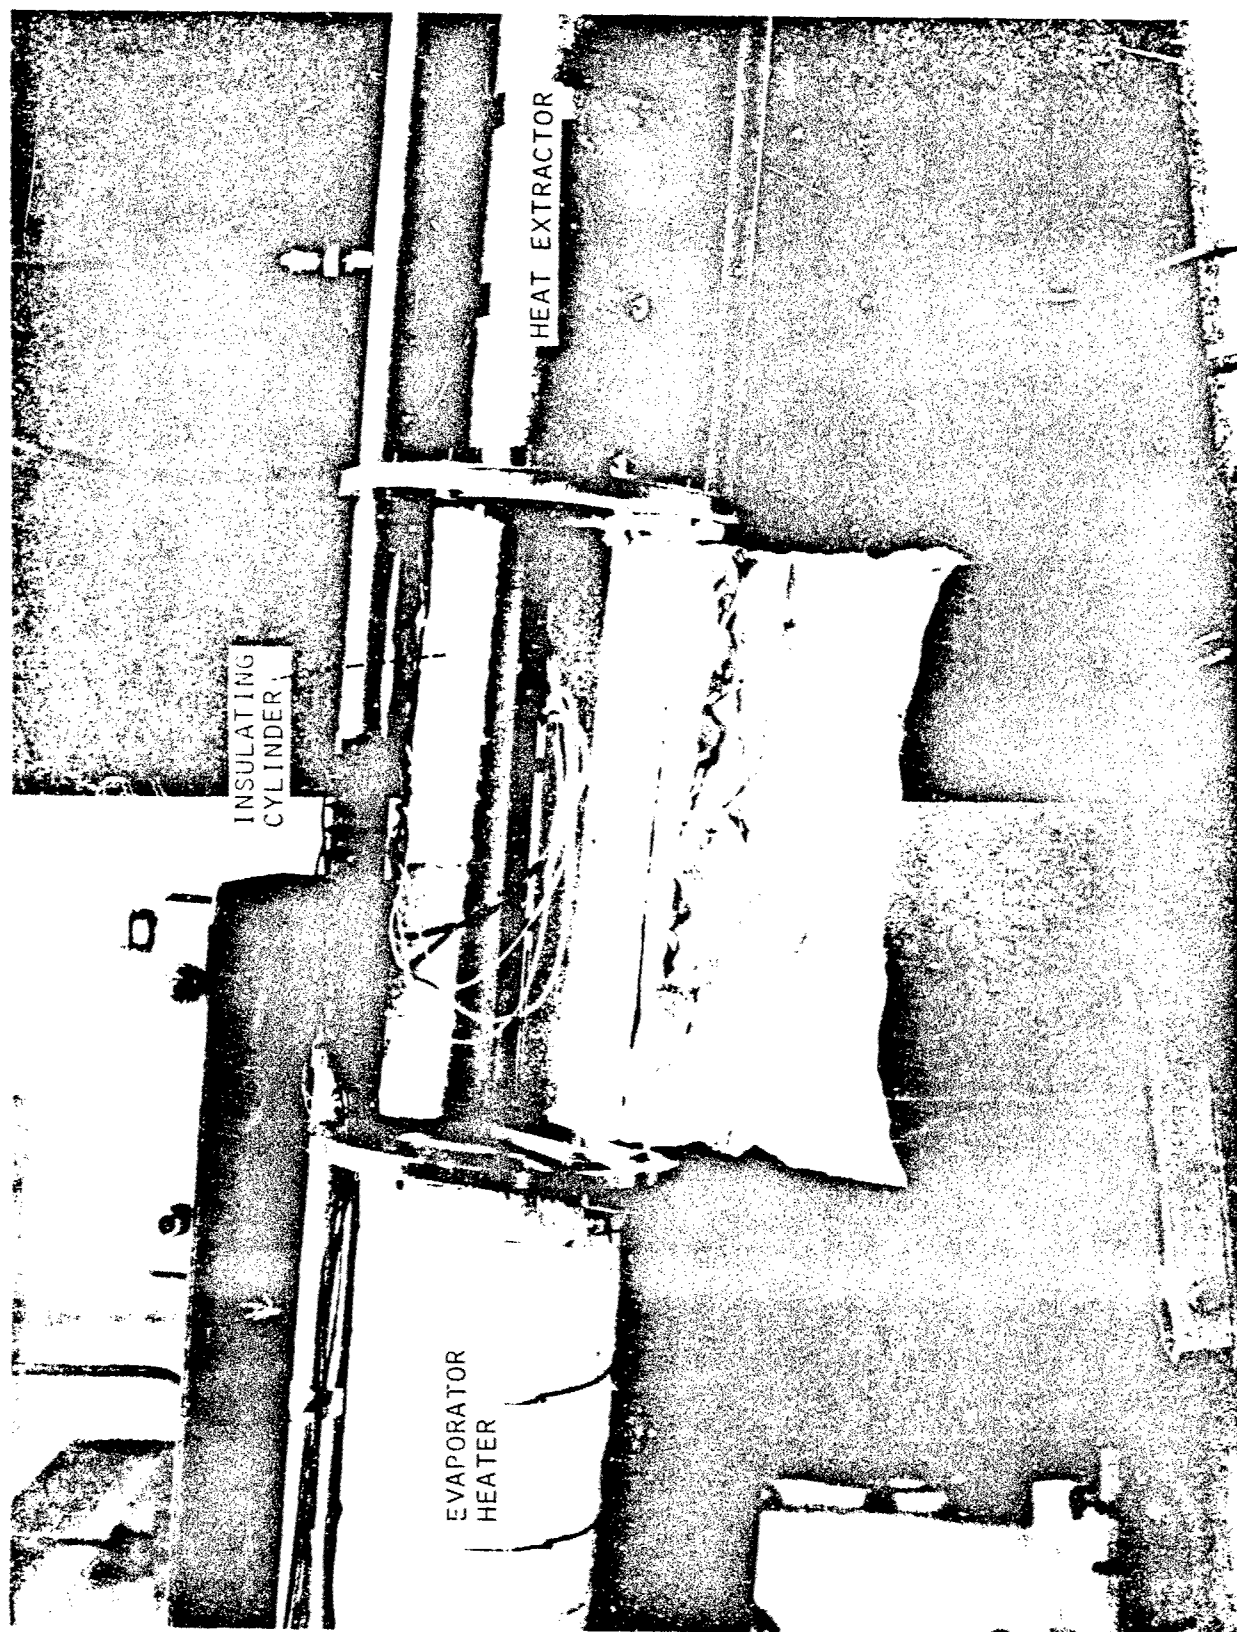
FIGURE 8. - ADIABATIC SECTION INSULATING TUBE, AIR STATIONS.

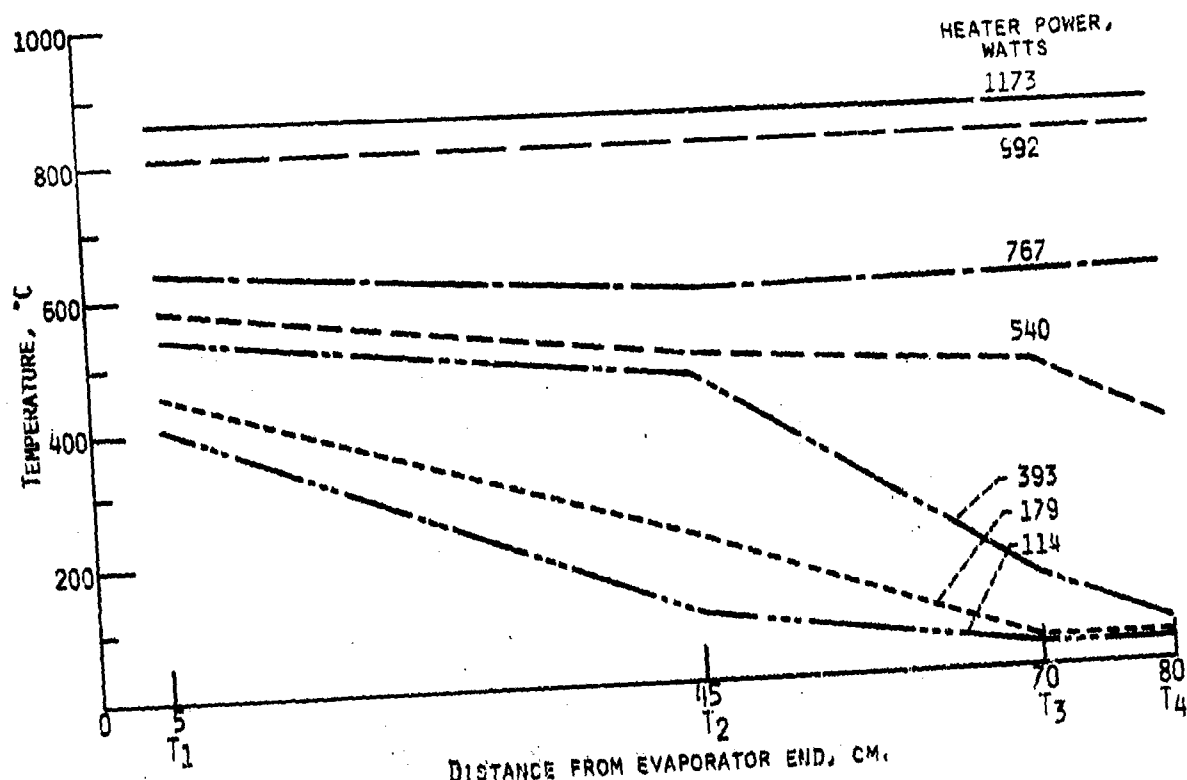
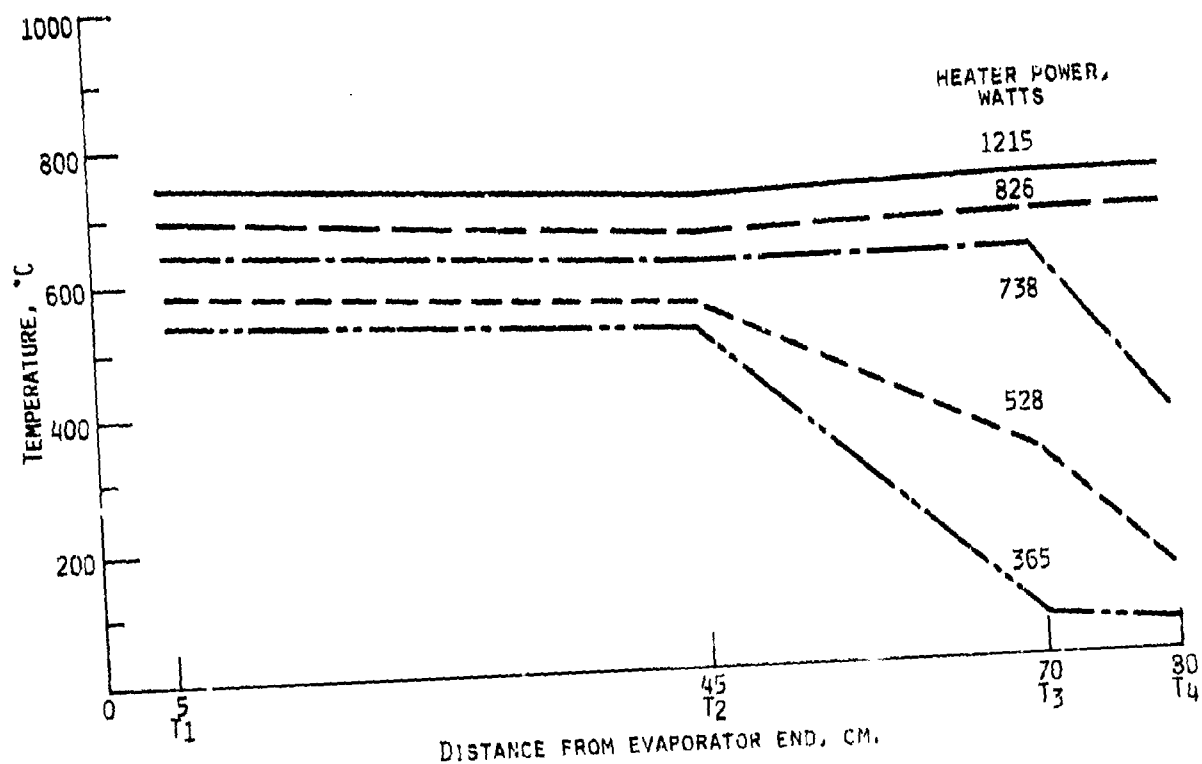
The profiles in Fig. 9(a) are from the data of a 304L stainless steel pipe (L-2) which had a screen wick of 200 mesh. The profiles in Fig. 9(b) are plotted from the data of Hastalloy B pipe HB-1, which had a metal fiber wick. A pipe was considered to be "started" and operating as a heat pipe when T_1 - T_4 was less than 30°C . For the sodium pipes the temperature indicated at T_1 , 5 cm from the evaporator end cap, had to reach about 640 to 670°C before the pipe started. Start up did not seem to be affected by the rate at which power was increased. For instance, if, when power was initiated, it was set immediately at a level which would rapidly bring T_1 to 800°C when equilibrium was reached, the pipe would start when T_1 passed through about 640°C . If on the other hand, power was initially set at a level which at equilibrium produced a temperature at T_1 of say 600°C , T_1 - T_4 would remain substantially greater than that of a started pipe. When power was then increased and T_1 reached about 640°C the temperatures at T_3 and T_4 would suddenly increase to give a relatively flat started pipe profile. Further increases in power would result in a higher and higher profile until

(A) SCREEN WICK - 304L, PIPE L-2.

FIGURE 9. - REPRESENTATIVE TEMPERATURE PROFILES DURING START-UP, SODIUM WORKING FLUID.

(B) METAL FIBER WICK, HASTALLOY B, PIPE HB-1.

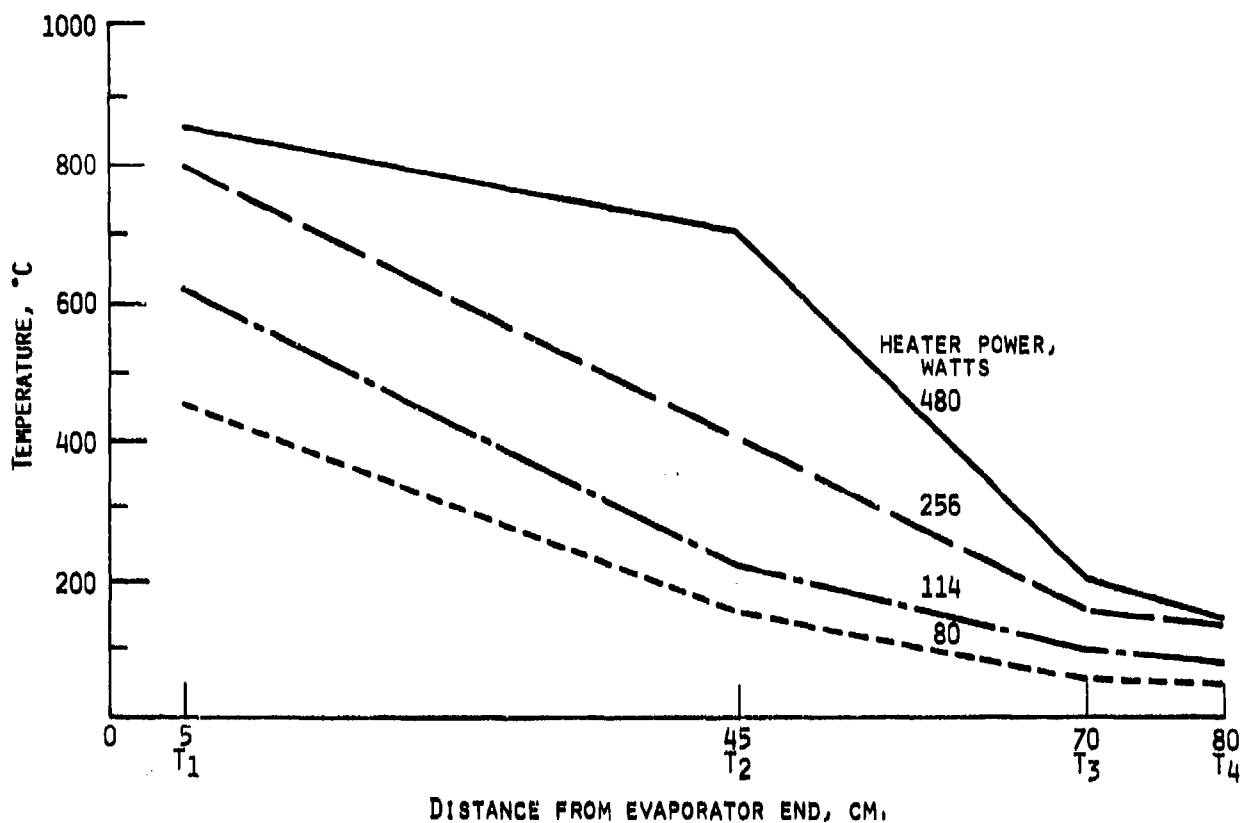
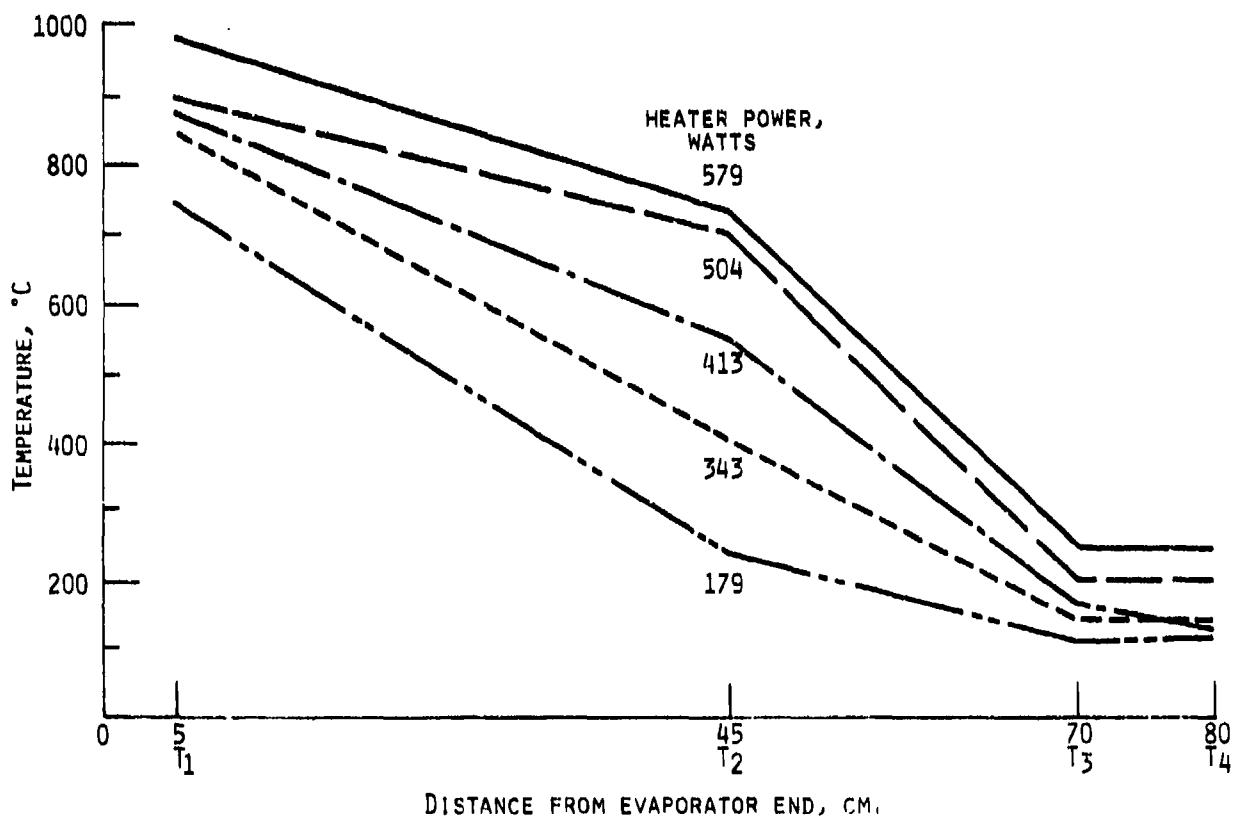
Start up temperature profiles for two of the lithium pipes can be seen in Figs. 10(a) and (b). The profiles in Fig. 10(a) are for a 310S stainless steel pipe (S-7) which, like the sodium pipe of Fig. 9(a), had a screen wick. Similar profiles are observed for the Haynes 188 pipe (HA-4) plotted in Fig. 10(b). Pipe HA-4, like HB-1 of Fig. 9(b), had a metal fiber wick. These two profile plots, representing the best of those for lithium pipes, indicate that the pipes were operating poorly at the temperatures reached. If higher evaporator temperature had been achieved, flatter profiles might have been attained in the lithium pipes. A subsequent section, Analysis of Performance, deals with this matter further.

(A) SCREEN WICK, 310S, S-7.

FIGURE 10. - REPRESENTATIVE TEMPERATURE PROFILES DURING START-UP, LITHIUM WORKING FLUID.

(B) METAL FIBER WICK, HAYNES 188, HA-4.

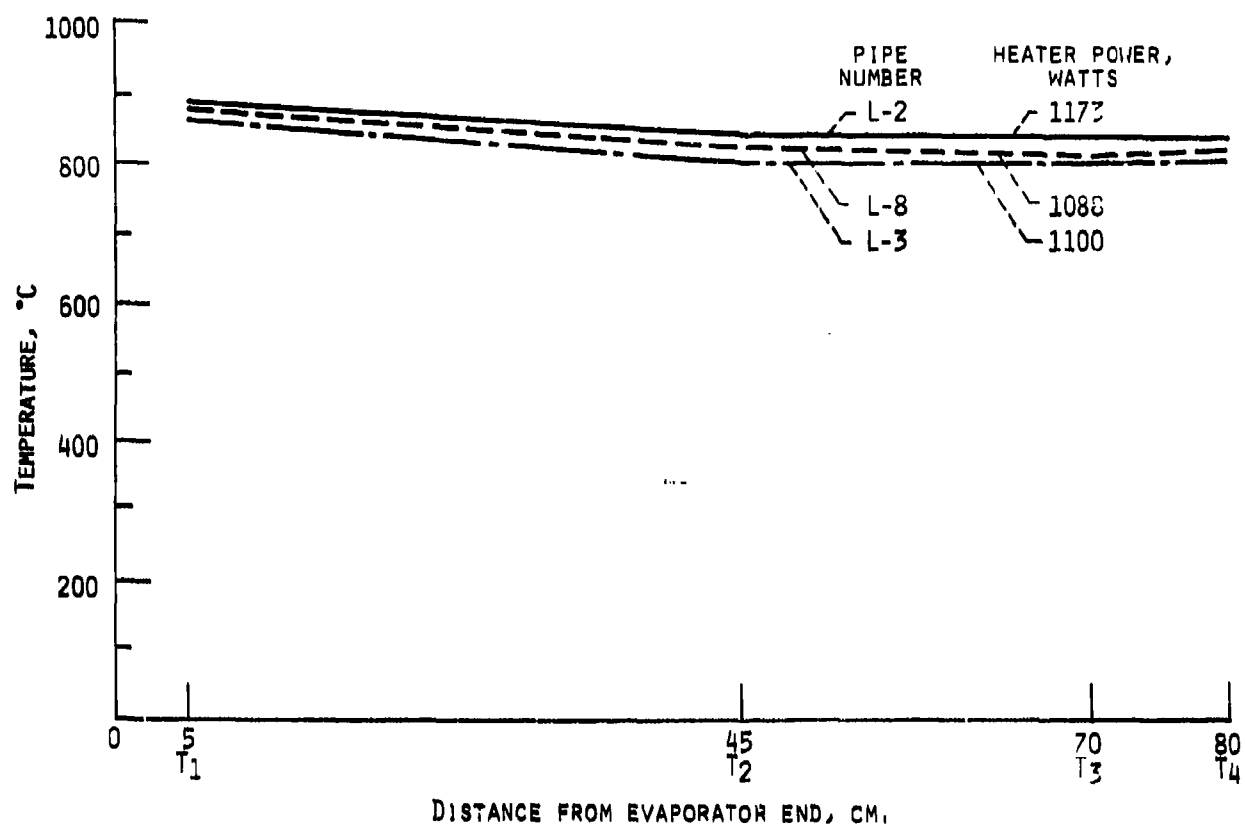
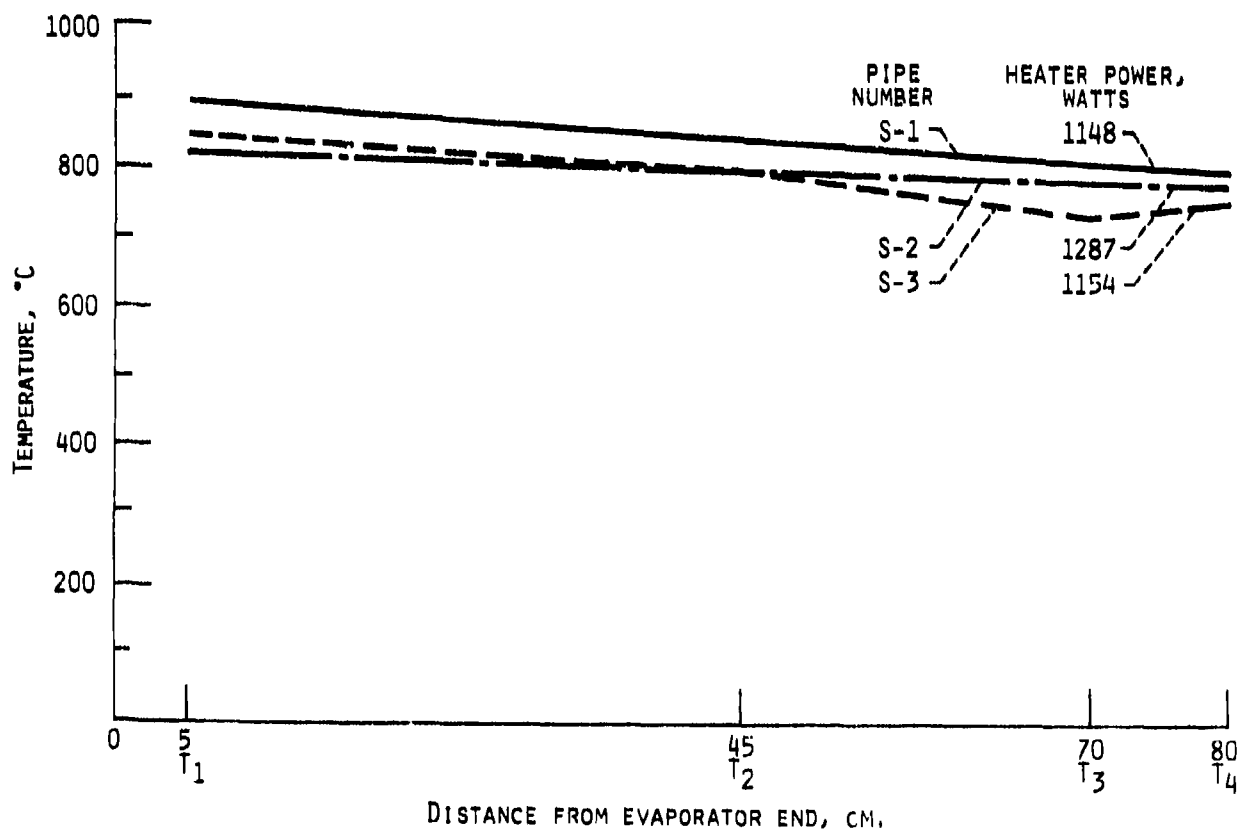
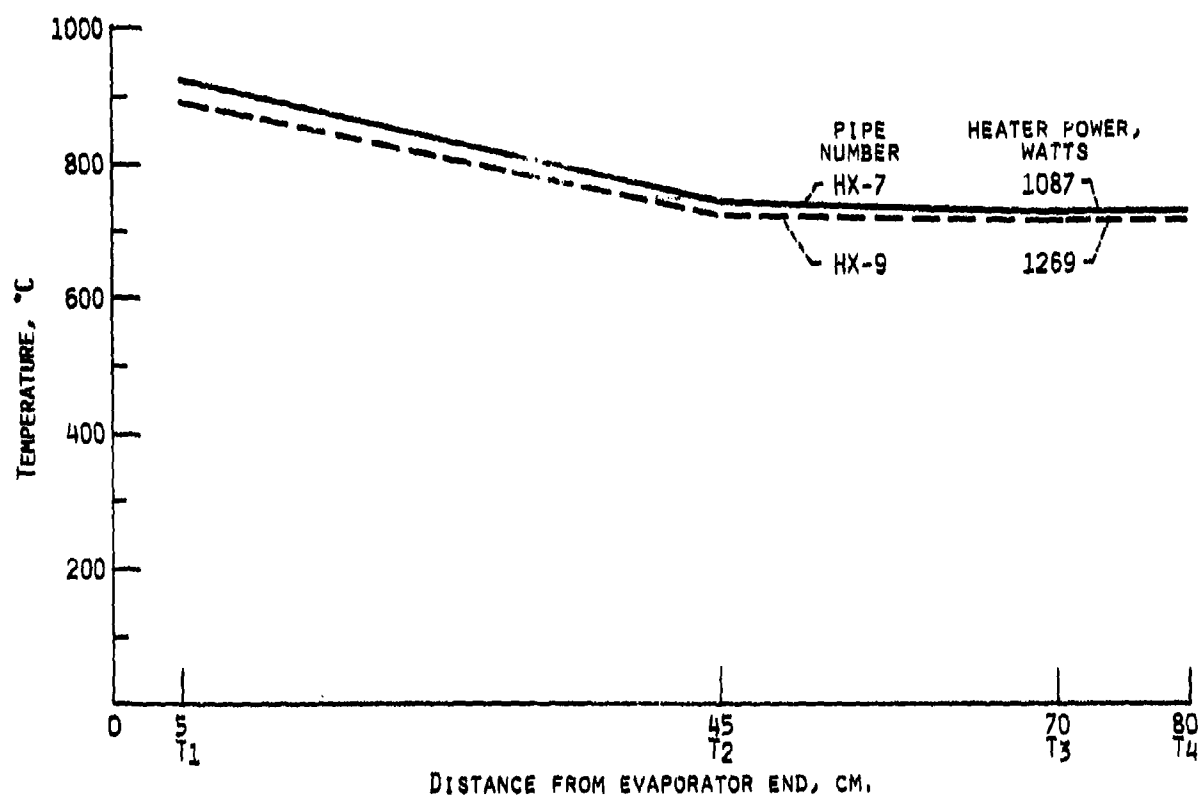
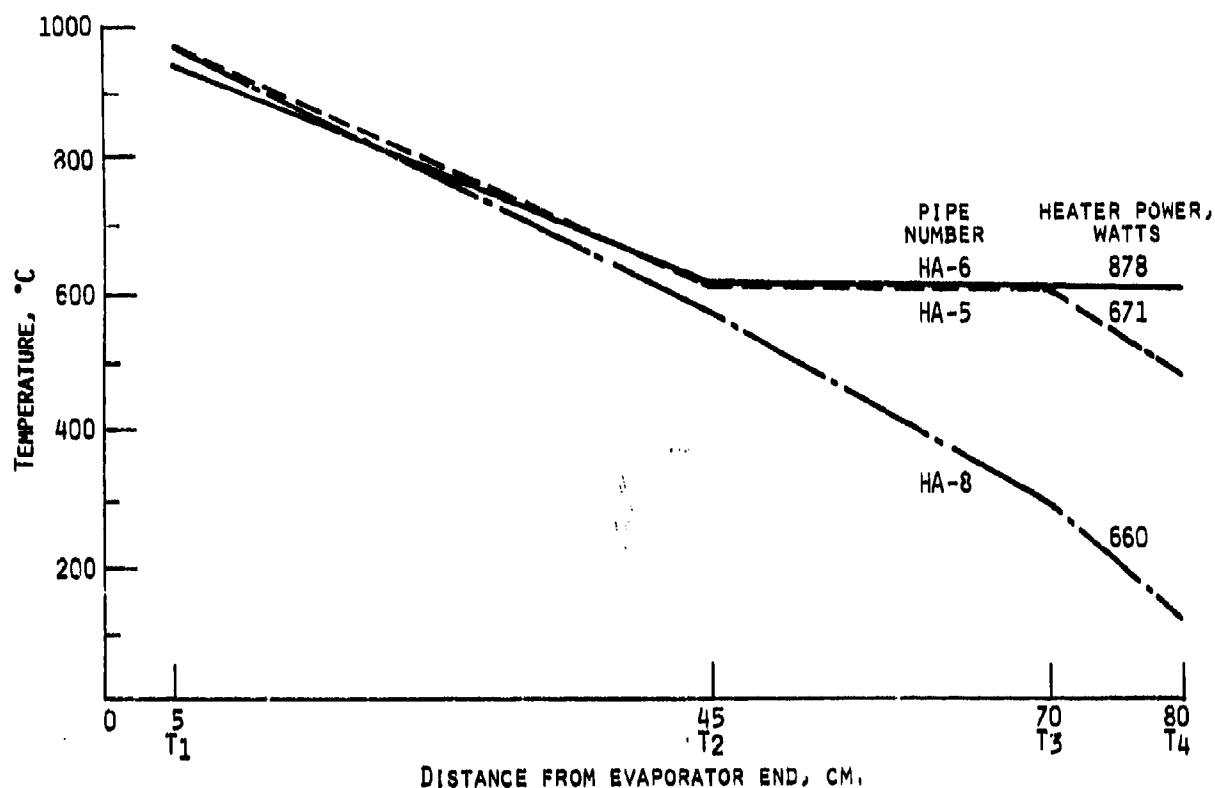
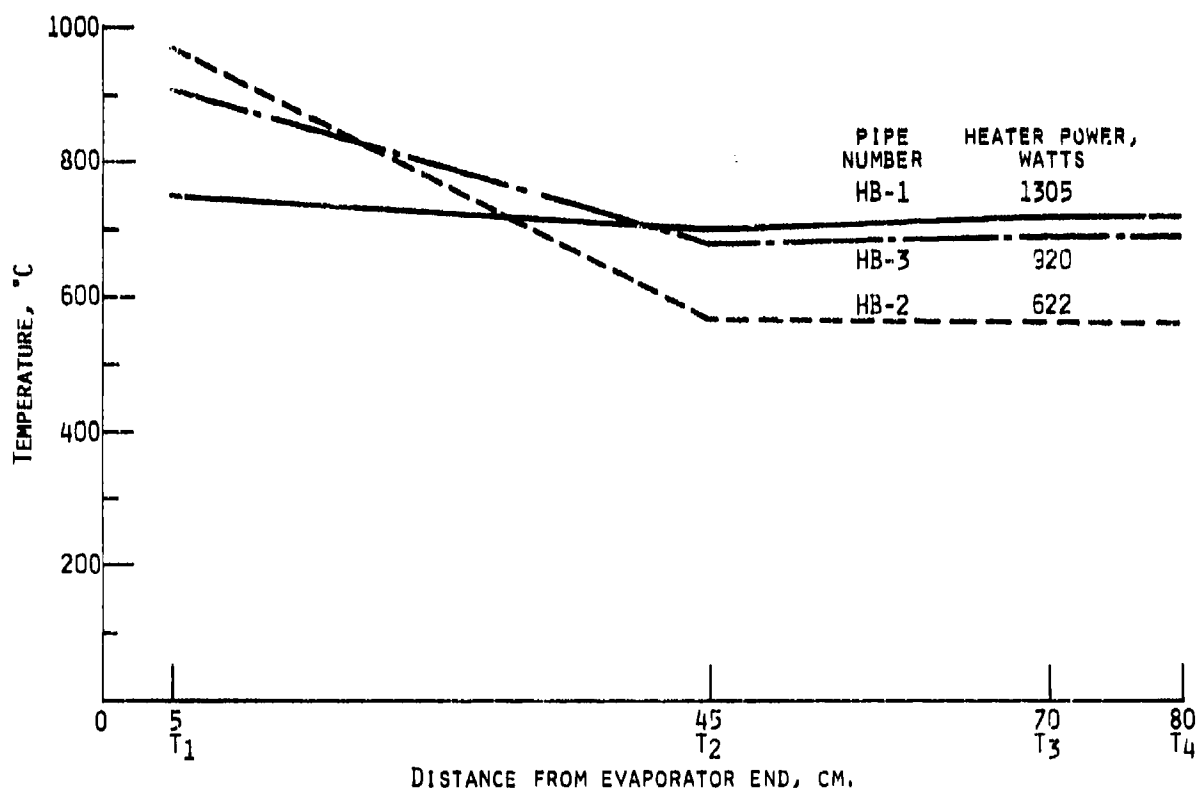
The steady state temperature profiles on Figs. 11(a) through (e) show that all 14 pipes with sodium as the working fluid did function. Those with screen wicks of 200 mesh (L-2 and L-3) and 100 mesh (L-8) (Fig. 11(a)), seemed to provide a slightly flatter profile and were more consistent than those having 60 mesh screen wicks (S-1 to S-3) (Fig. 11(b)). All the pipes having screen wicks appeared to perform better than those with metal fiber wicks (Figs. 11(c) to (e)). Pipe HA-8 (Fig. 11(d)), appears to represent a case of a damaged or improperly installed wick.

(A) SCREEN WICKS, 304L PIPES.

FIGURE 11. - TYPICAL STEADY-STATE TEMPERATURE PROFILES FOR SODIUM FILLED PIPES.

(B) SCREEN WICKS, 310S PIPES.

(C) METAL FIBER WICKS, HASTALLOY X PIPES,

(D) METAL FIBER WICKS, HAYNES 188 PIPES.

(E) METAL FIBER WICKS, HASTALLOY B PIPES.
